SUBJECT John Anglin, Clarence Anglin and
Frank Lee Morris Escape from Alcatraz

FILE NUMBER 76-26295

VOLUME NUMBER Enclosures 76, 137, 155 and 179

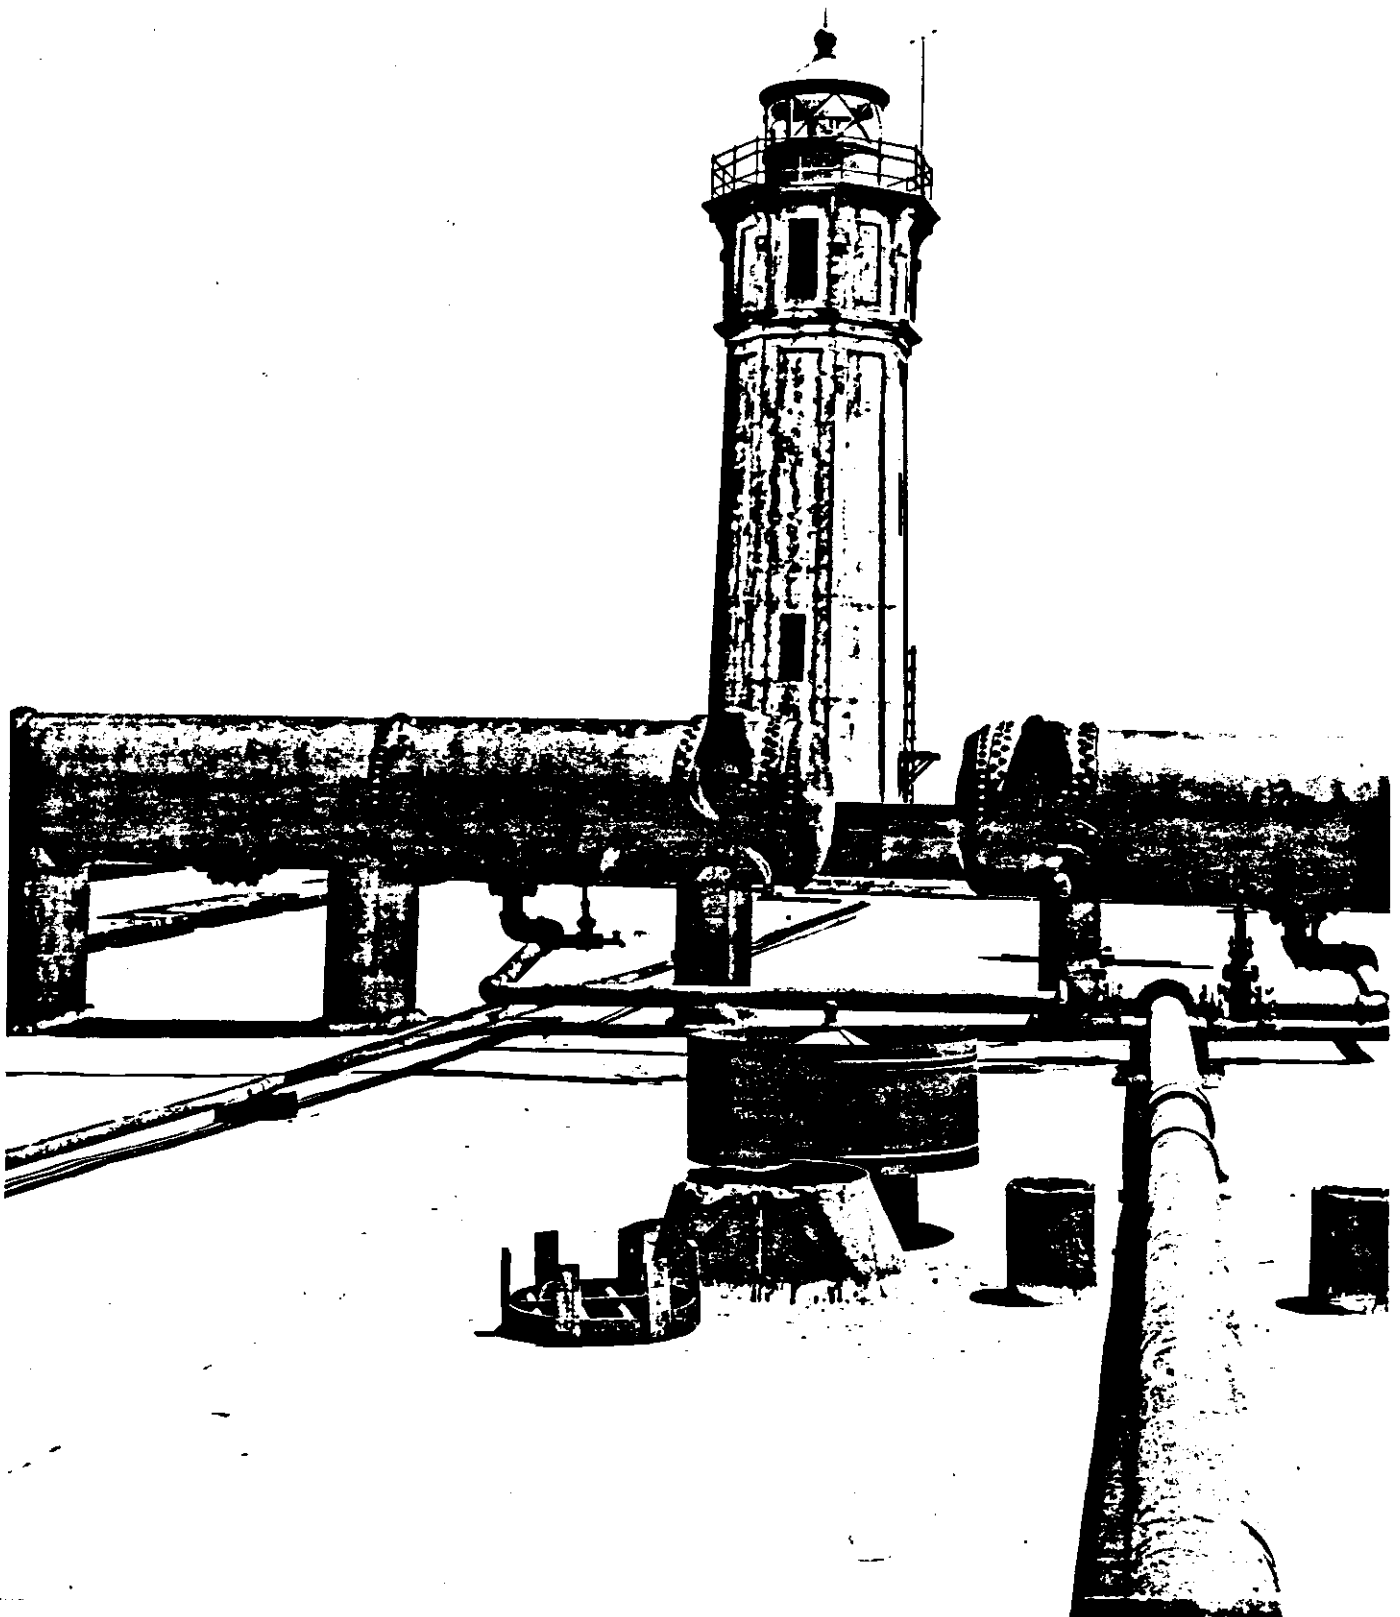
1-6 Photograph taken on the top of building comprising Cell Block B looking in a southeast direction showing general view of building top with the Coast Guard lighthouse center rear. This lighthouse is not manned except in cases of emergency.

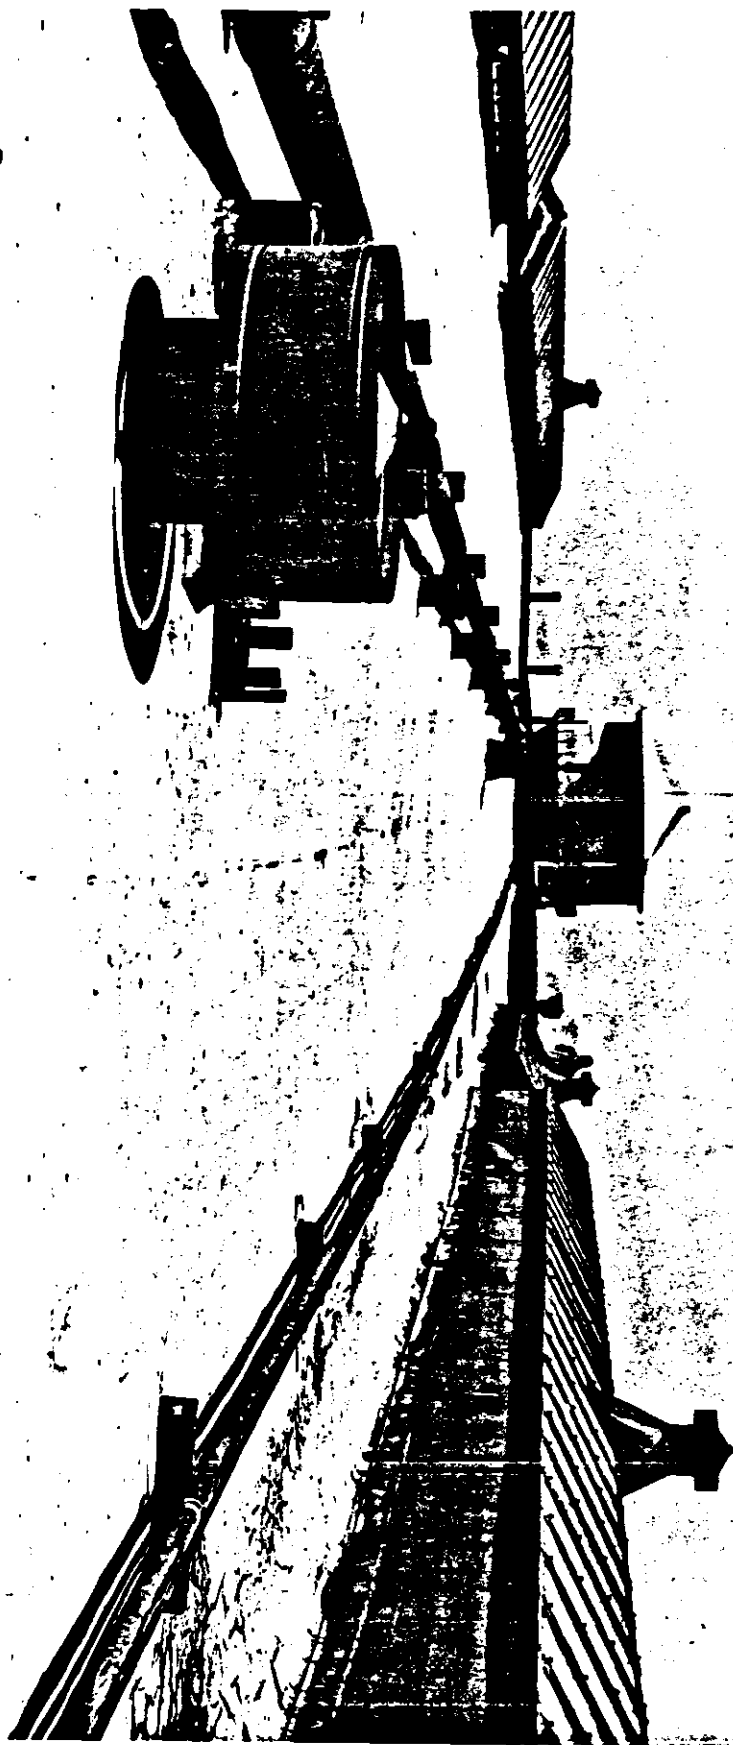
- 1-7 Photograph taken approximately twenty-five feet southeast of ventilator opening looking in a general northwesterly direction along the roof over Cell Block B toward water tower and is the direction foot prints led. The large skylights appearing on right and left center are skylights over the area between Cell Block A and B and at the far end of the photograph just below the catwalk around the water tower may be seen the catwalk which encircles the perimeter of the building and at the point where the pipes meet the end of the wall the catwalk drops down to a lower elevation of about six feet to eight feet and the far end of the building is reached by the catwalk.

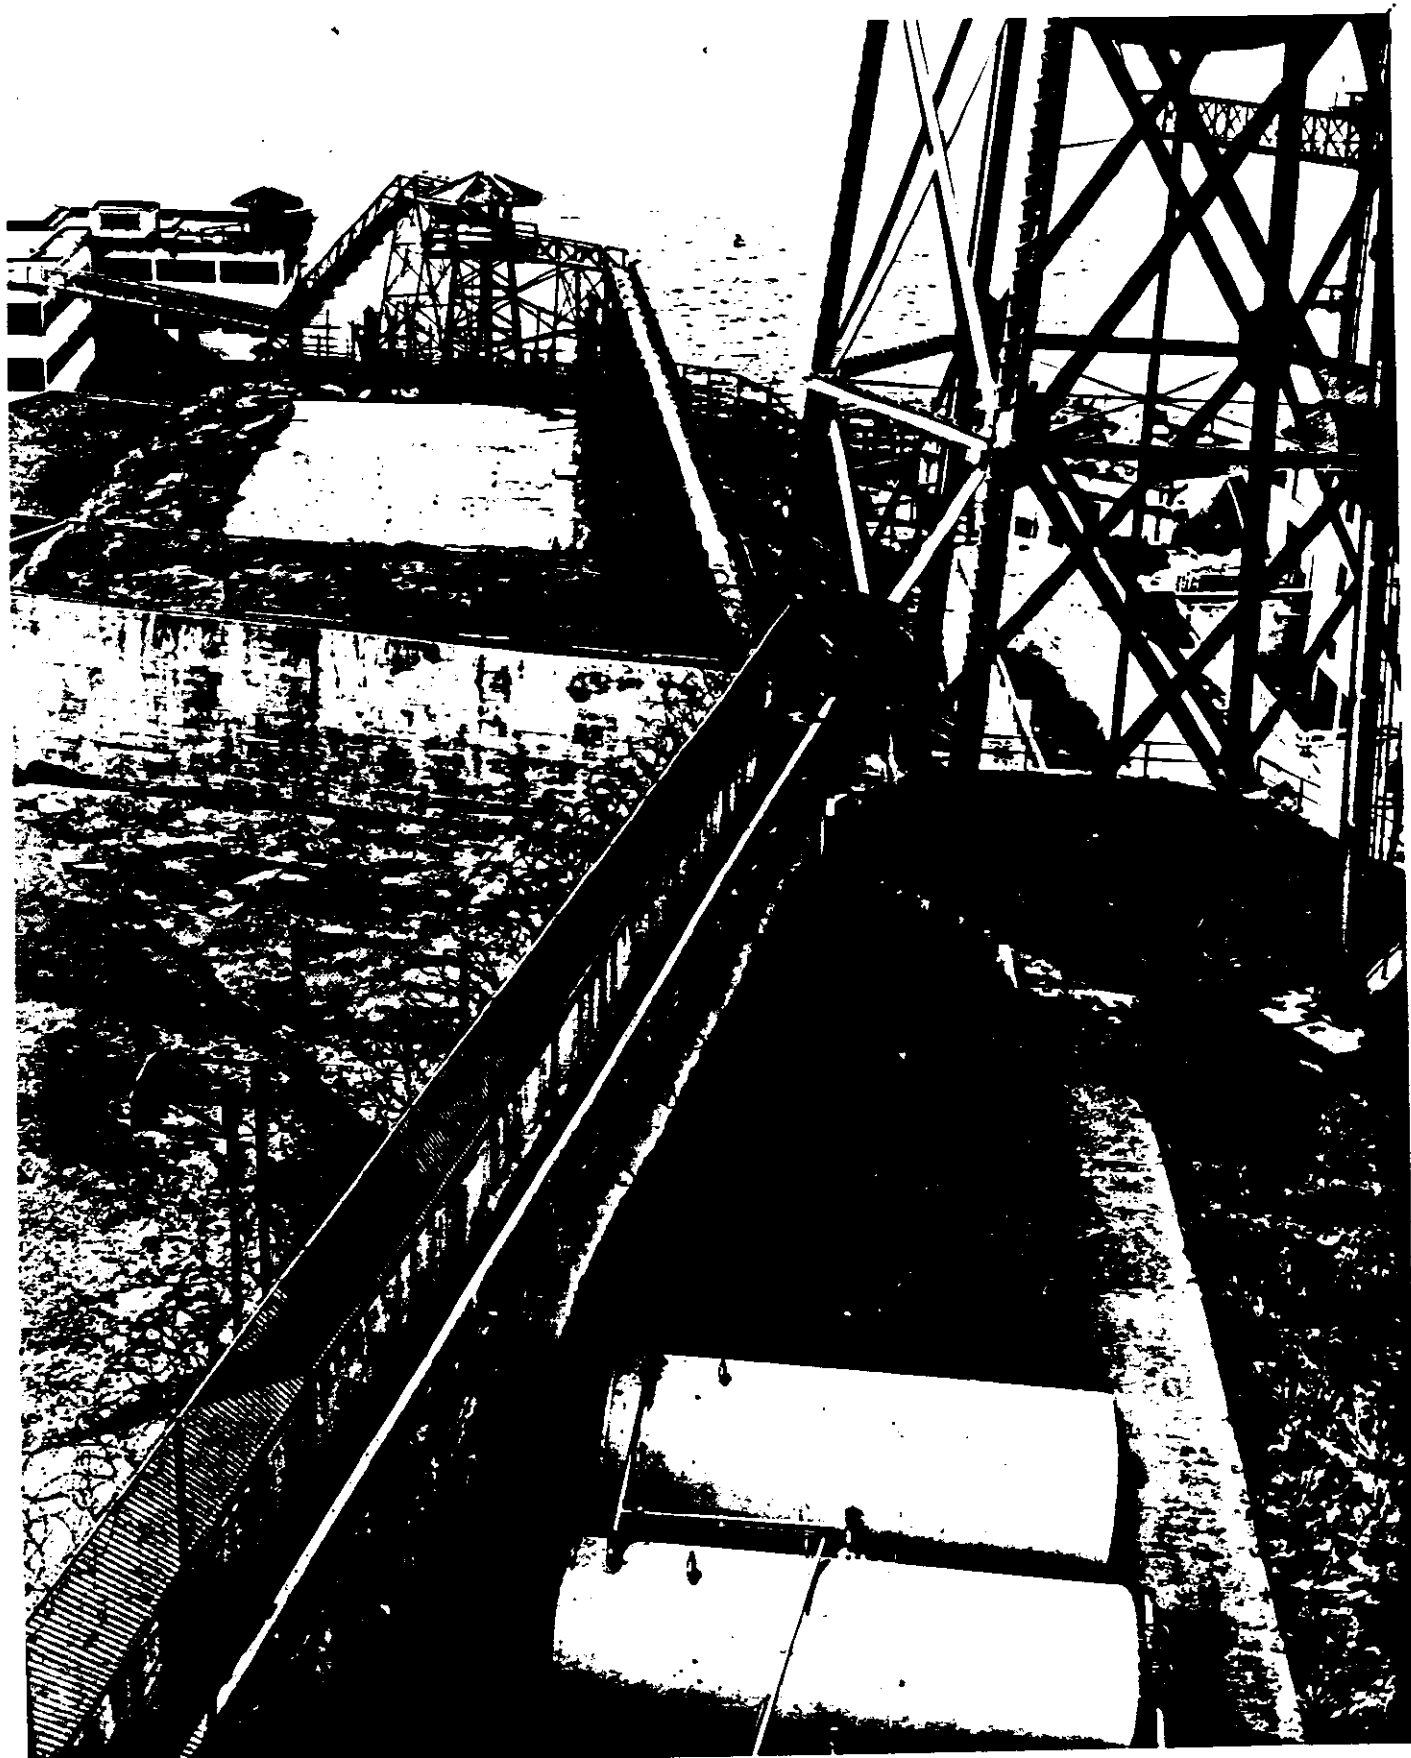
2-2 A general northern view taken from the top of the prison building. The area immediately to the left and center is the recreation area and at the far end may be seen guard tower number 4 and guard tower number 3 and guard tower number 2. None of these guard towers are manned during the night.

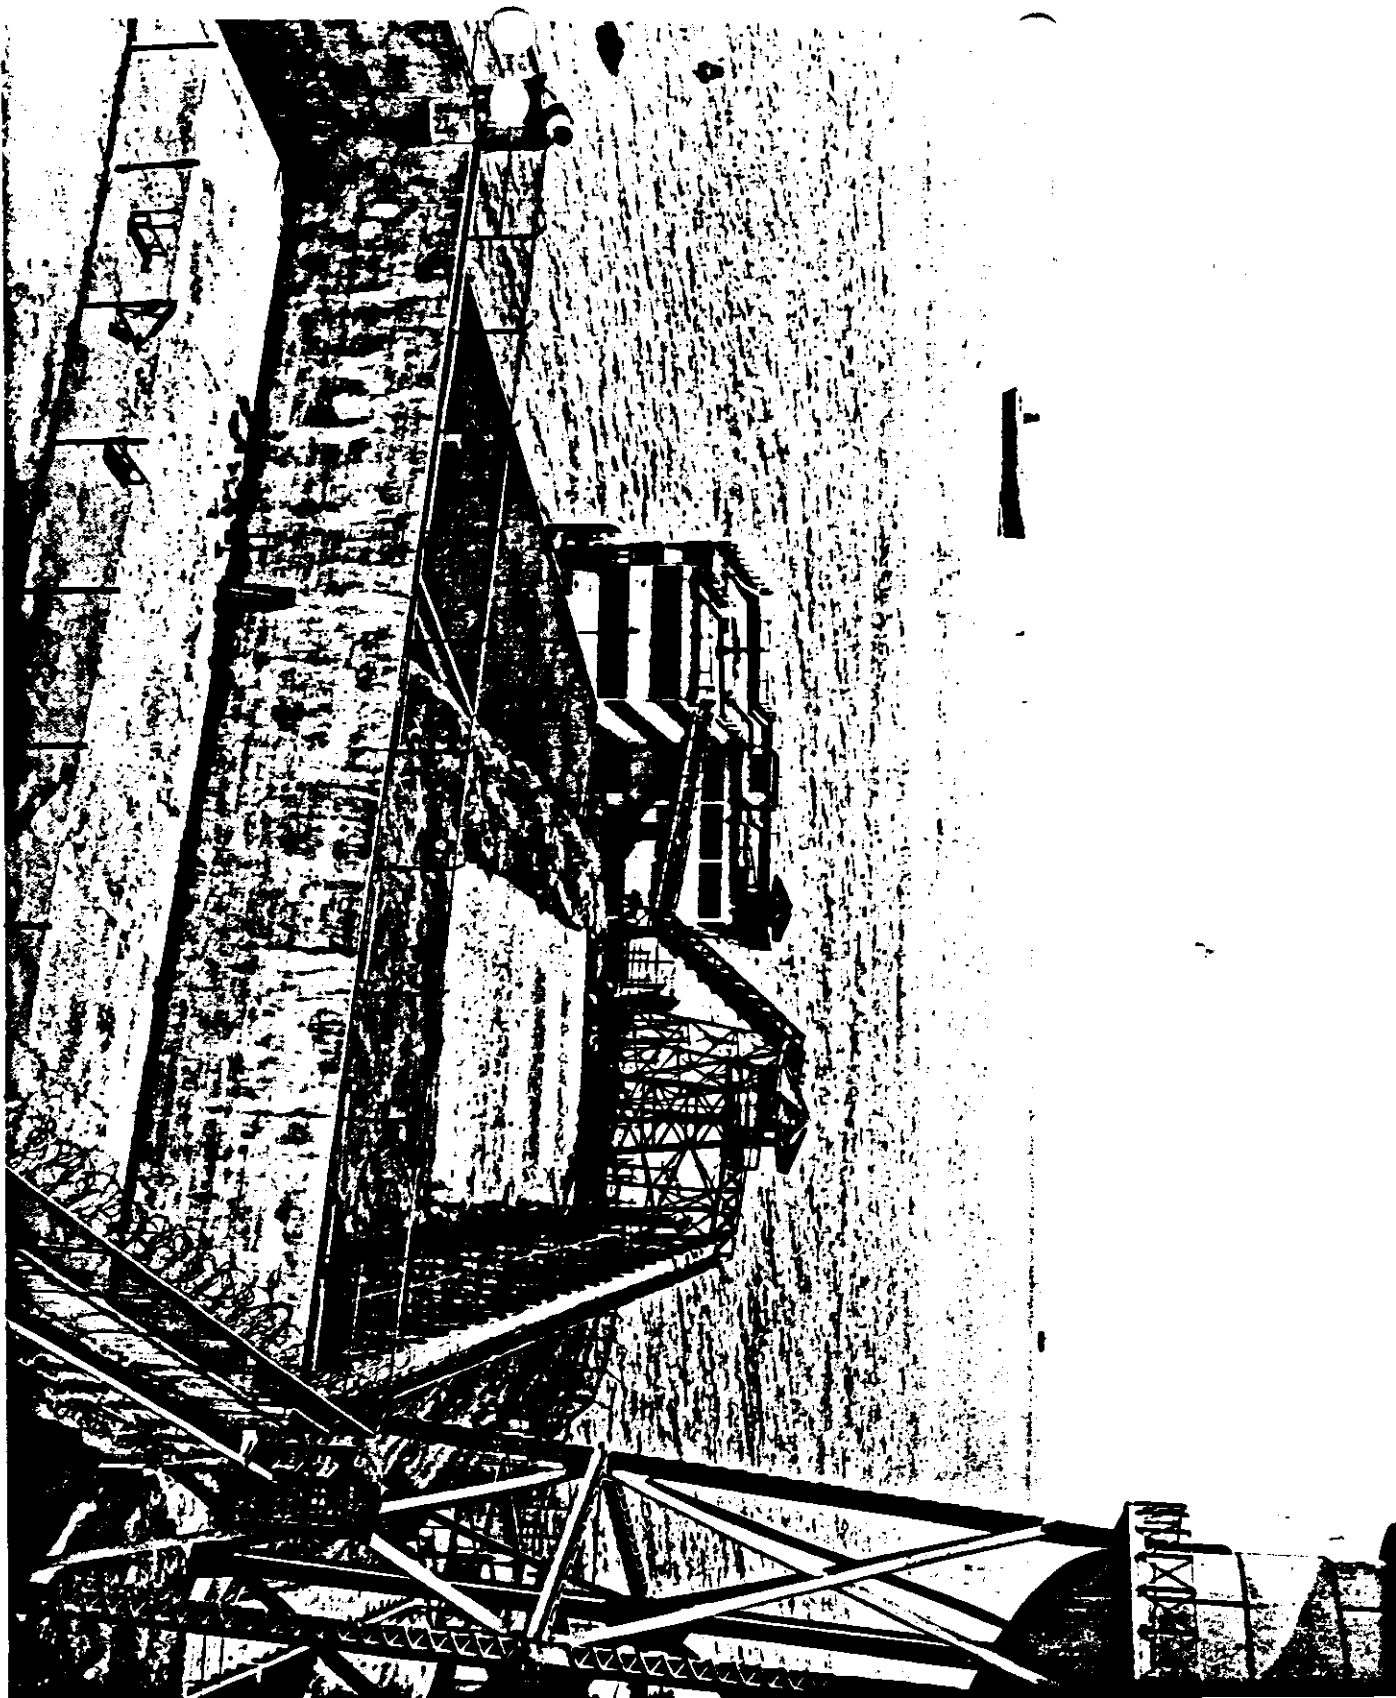
2-3 Same general view as 2-2 except that a larger portion of the recreation area is visible.

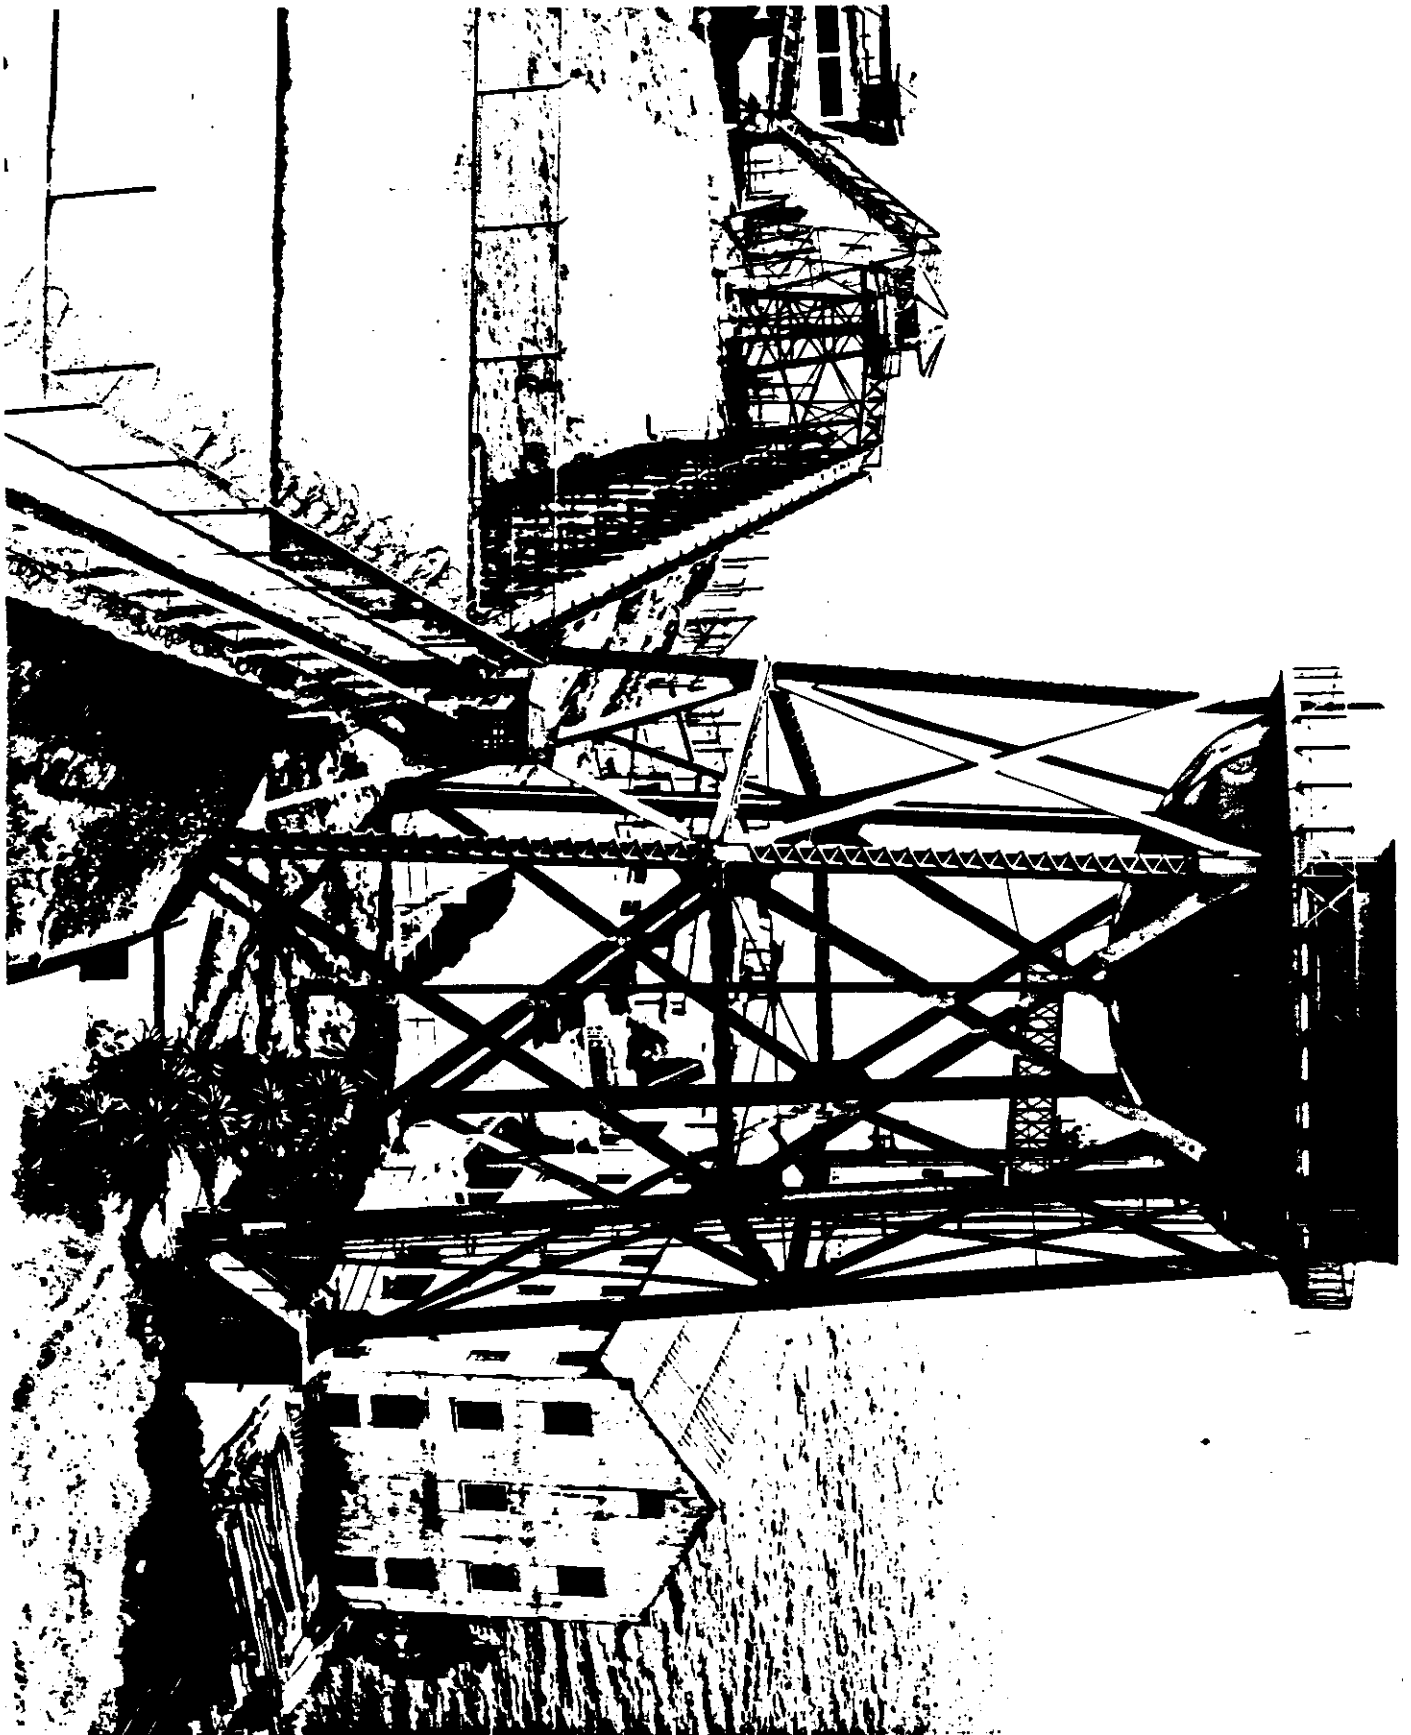
2-4 Same general view as previous photographs with the exception that the industrial building is shown in more detail.

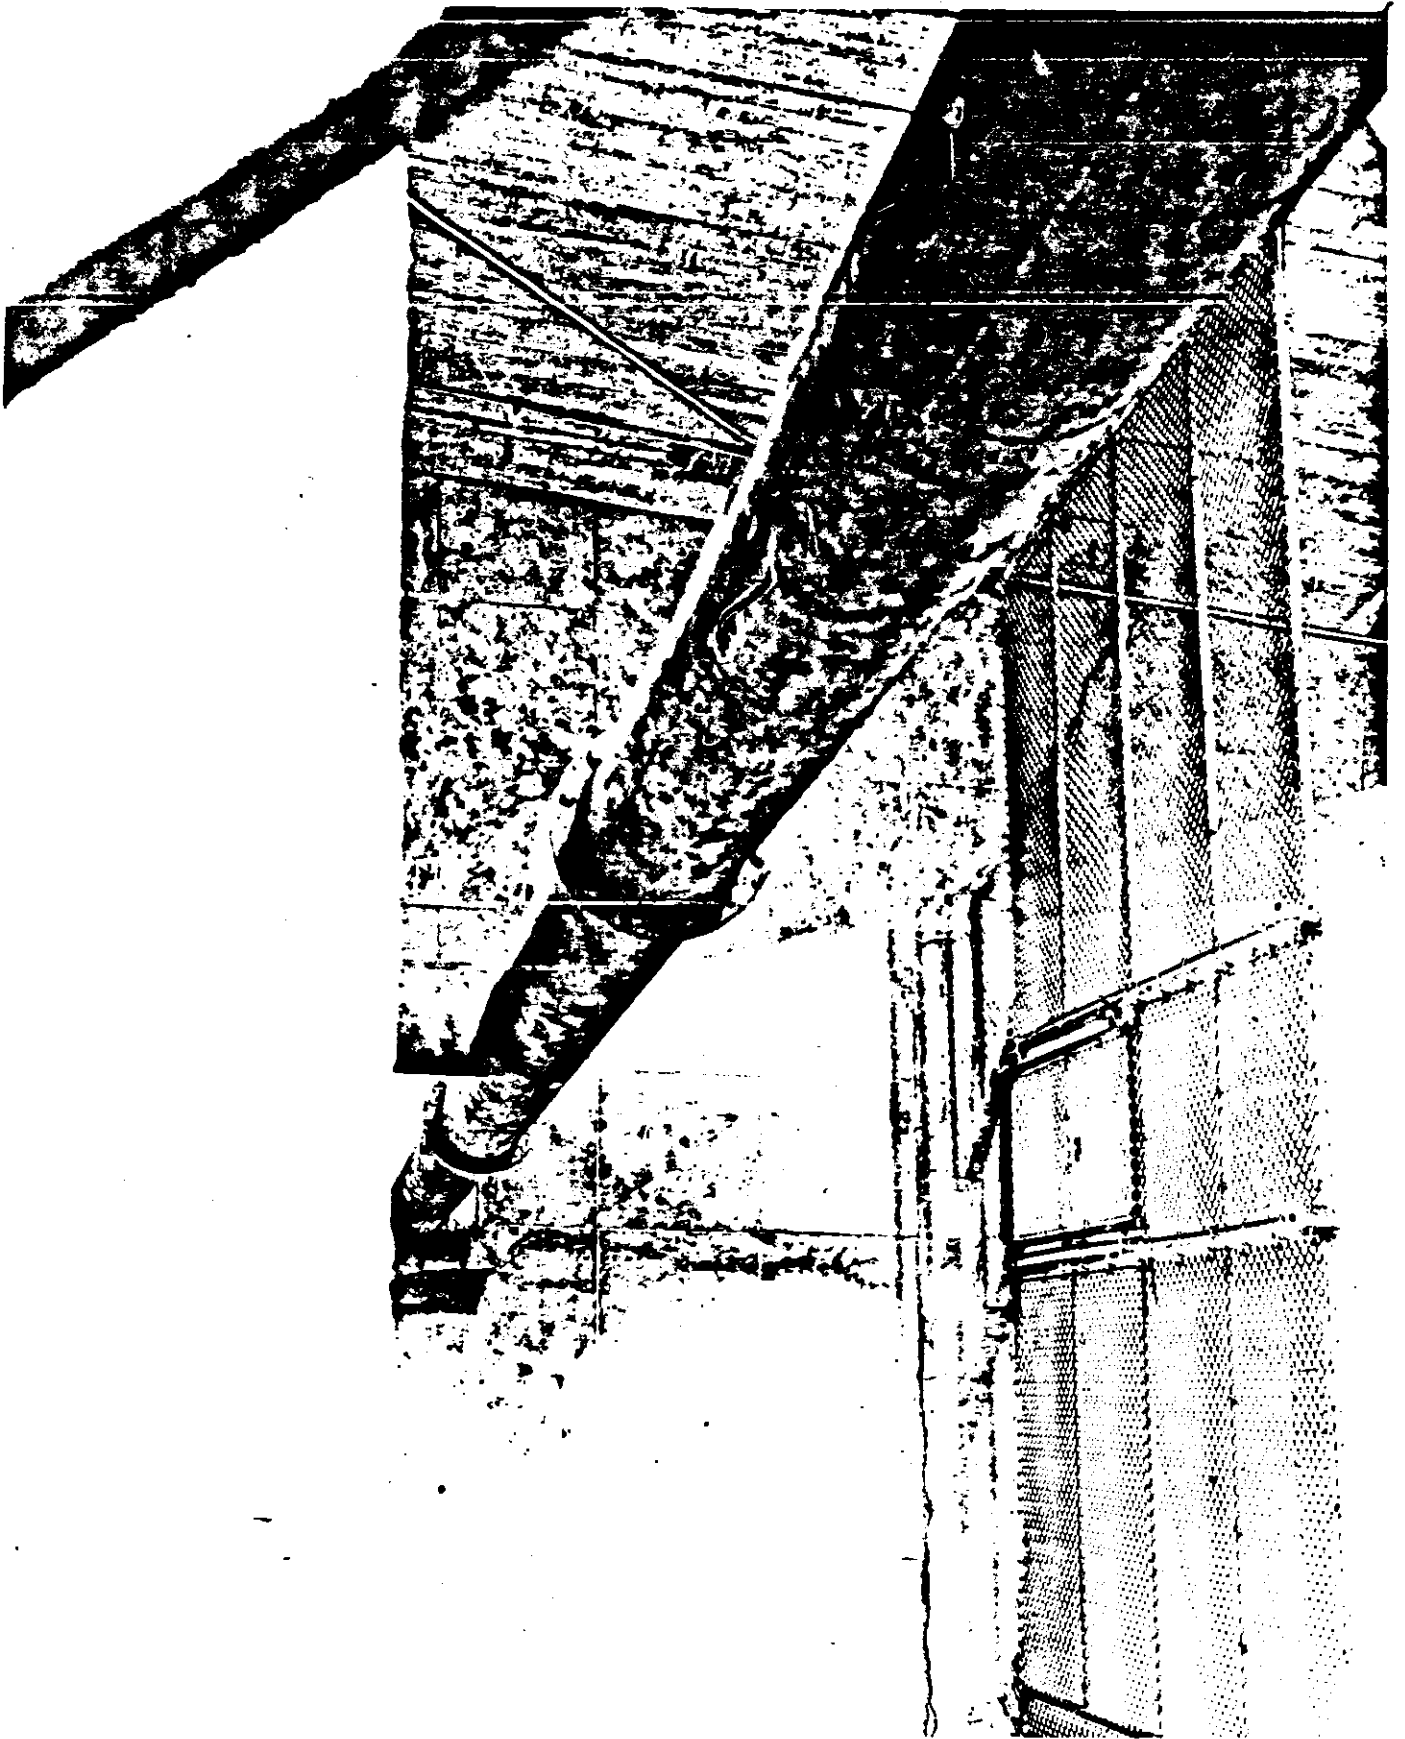
2-8 Same general view as 2-7.

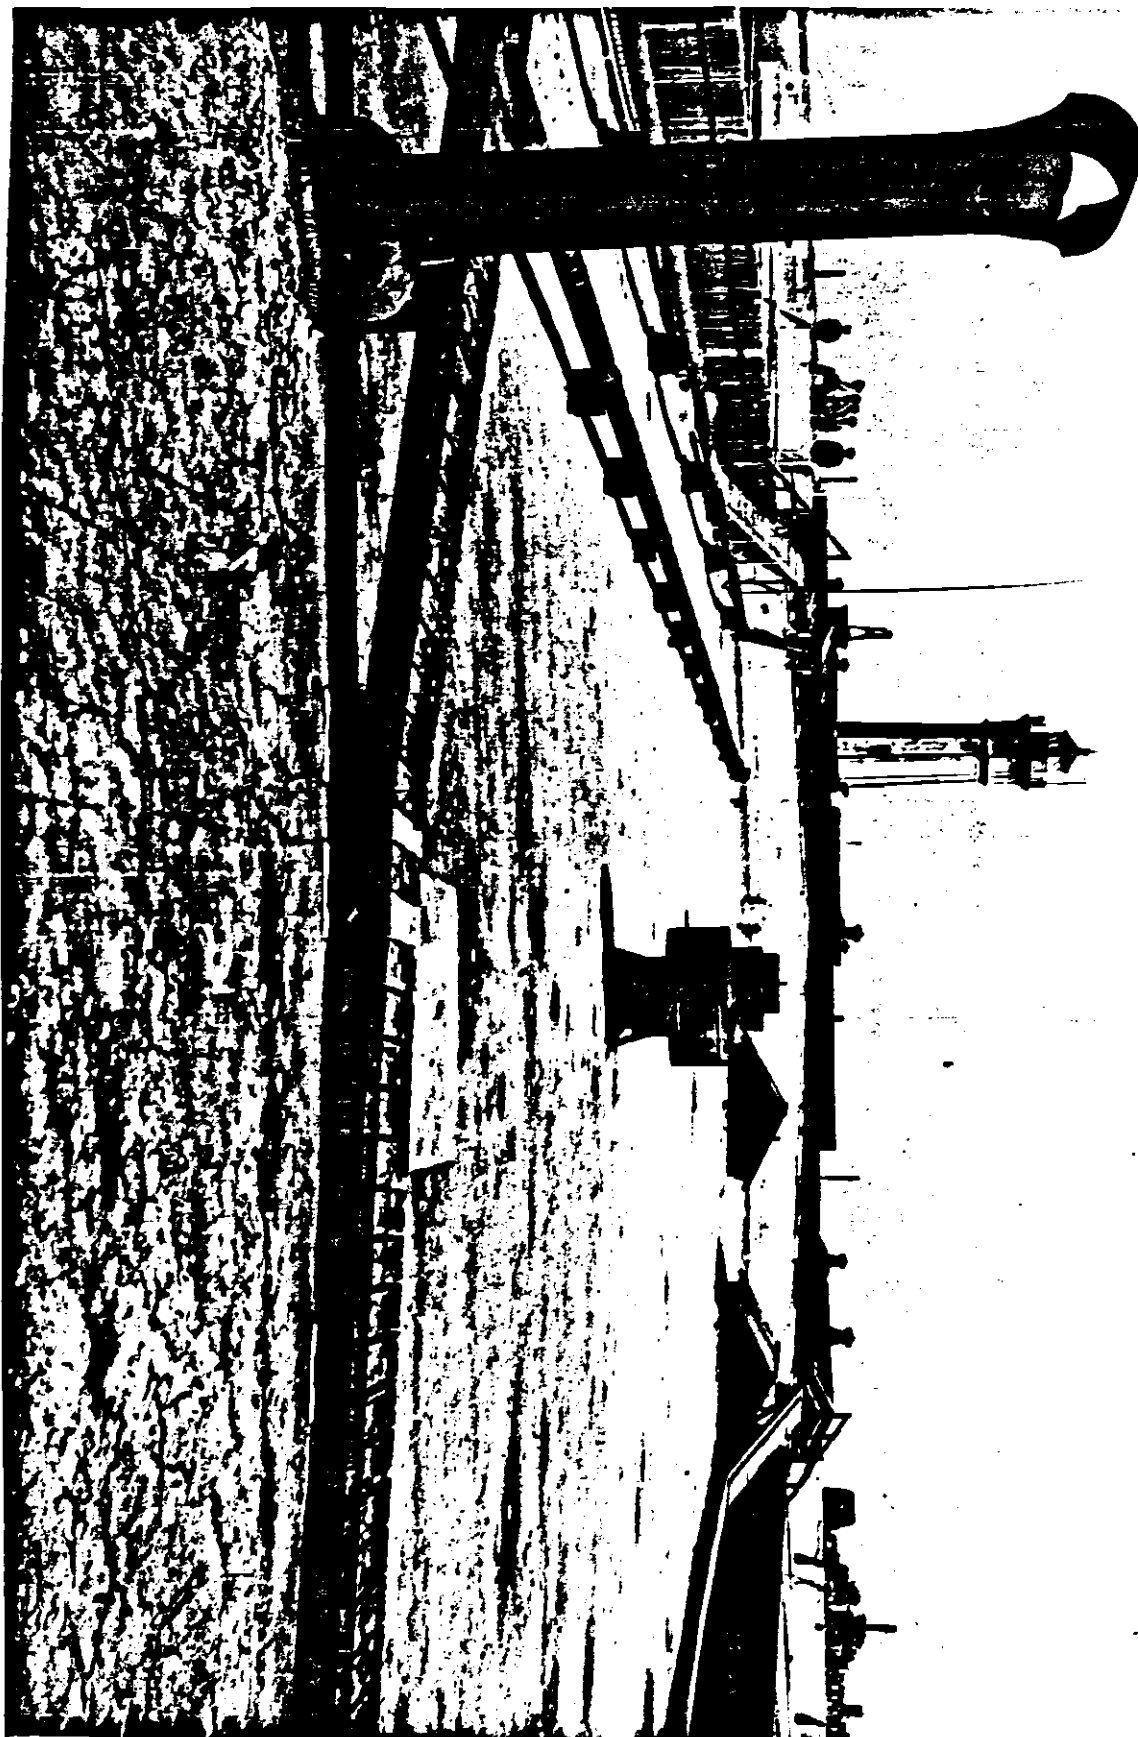
2-10 Photograph taken showing general roof area looking in a southerly direction from the bake oven stack toward the Coast Guard lighthouse. The change in the roof elevation from Cell Block A, B, and C, etc., may be observed with catwalks running on both sides of the picture. A paddle was found under the catwalk in approximate location indicated by the individuals seen in the photograph left center.

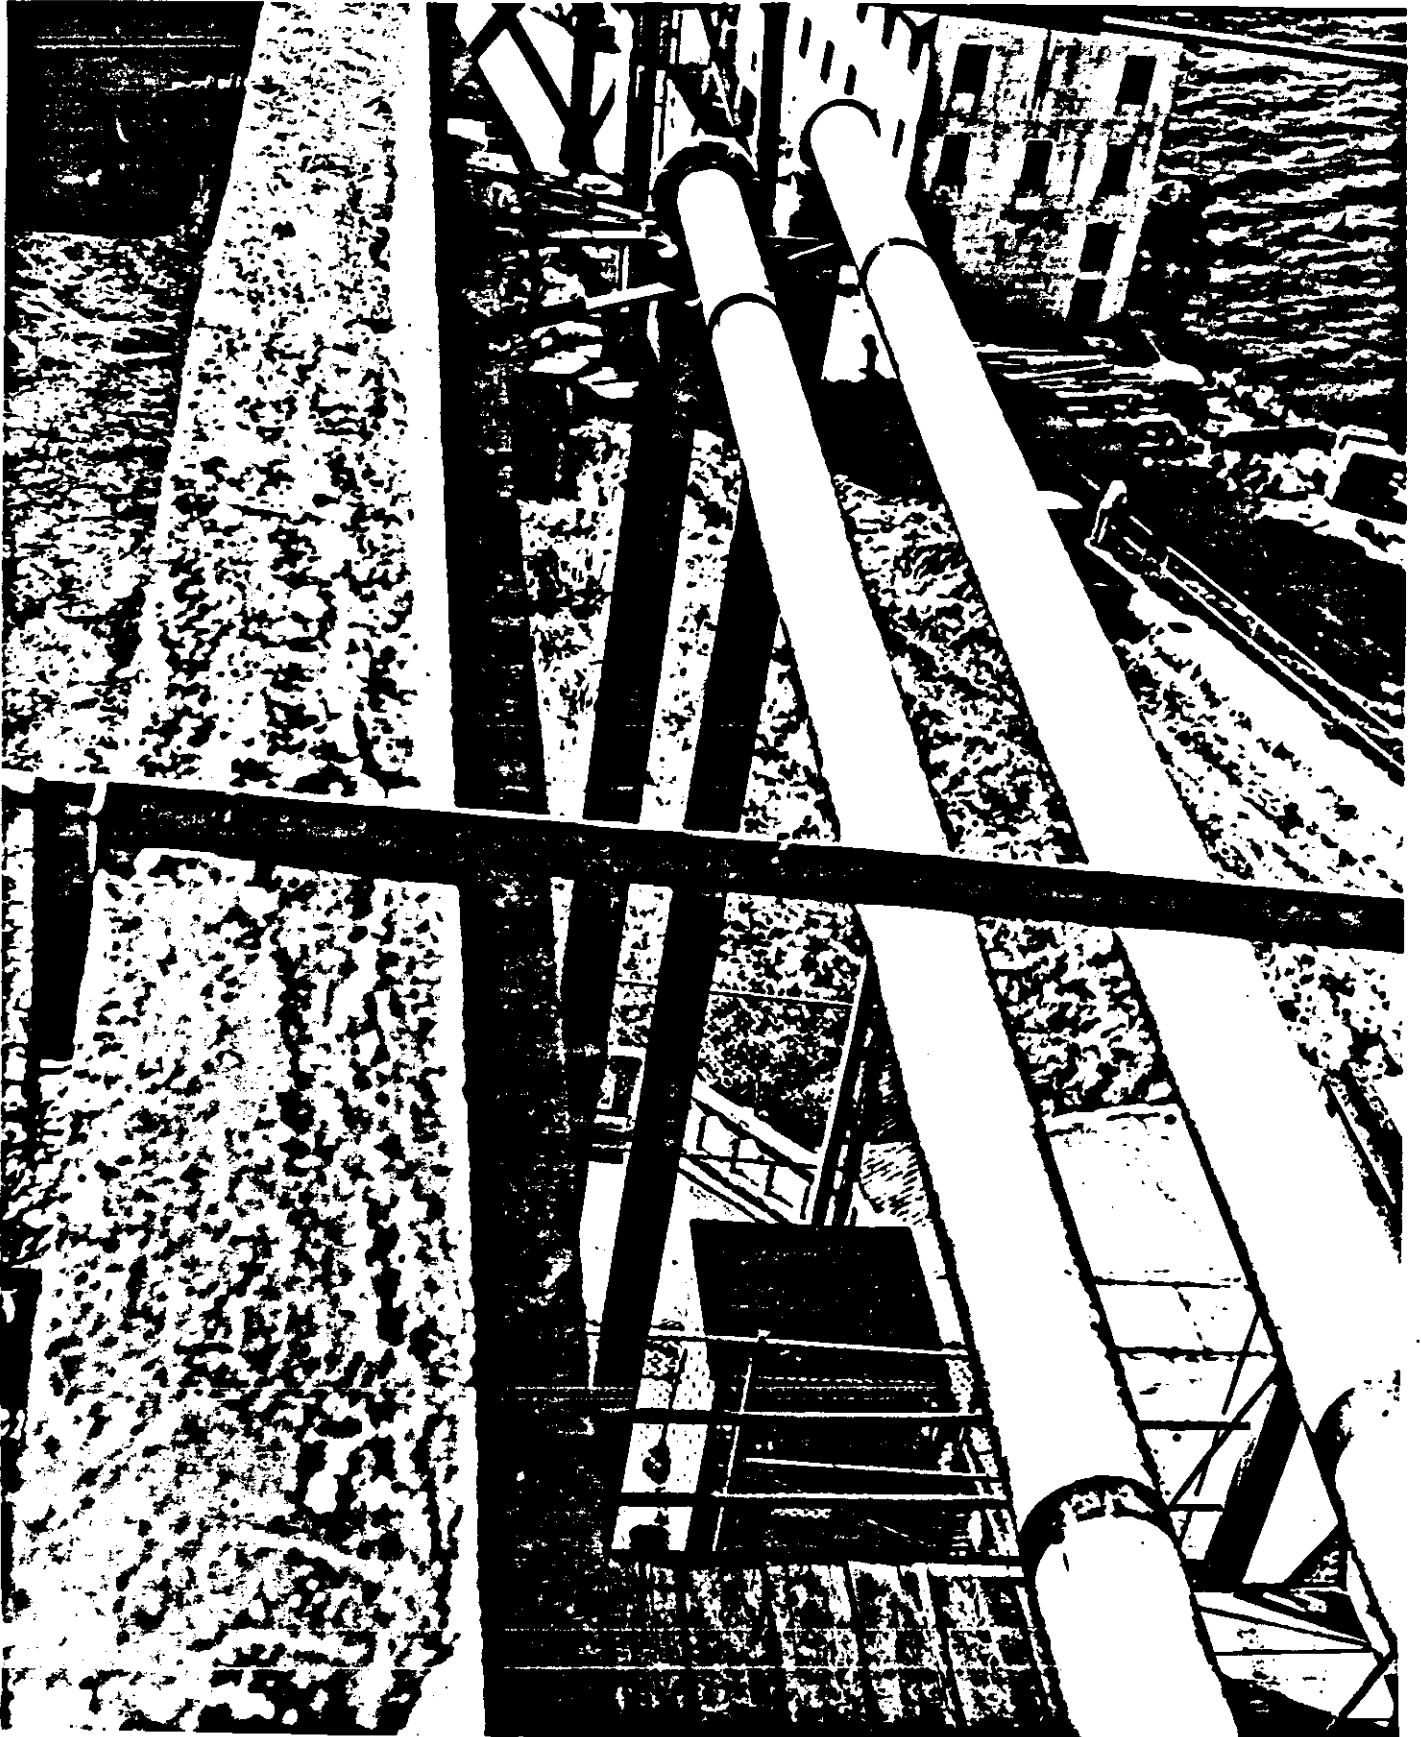
2-11 Photograph taken from roof of building at the northeast corner showing aluminum-plated utility pipes descending to ground level. These pipes are approximately six inches in diameter. Lower center of photograph shows the landing outside of the third floor entrance to the prison building. Stairs lead from this landing to the ground level in the same area as shown in photograph 1-12, however this corner of the building is illuminated by three flood lamps and is clearly visible to the guard in tower number 1 which is manned twenty-four hours a day. The angle iron crossbrace shown in the center of the photograph is the type used to support the illumination. Upper left hand corner shows the type of electrical connection for these lamps.

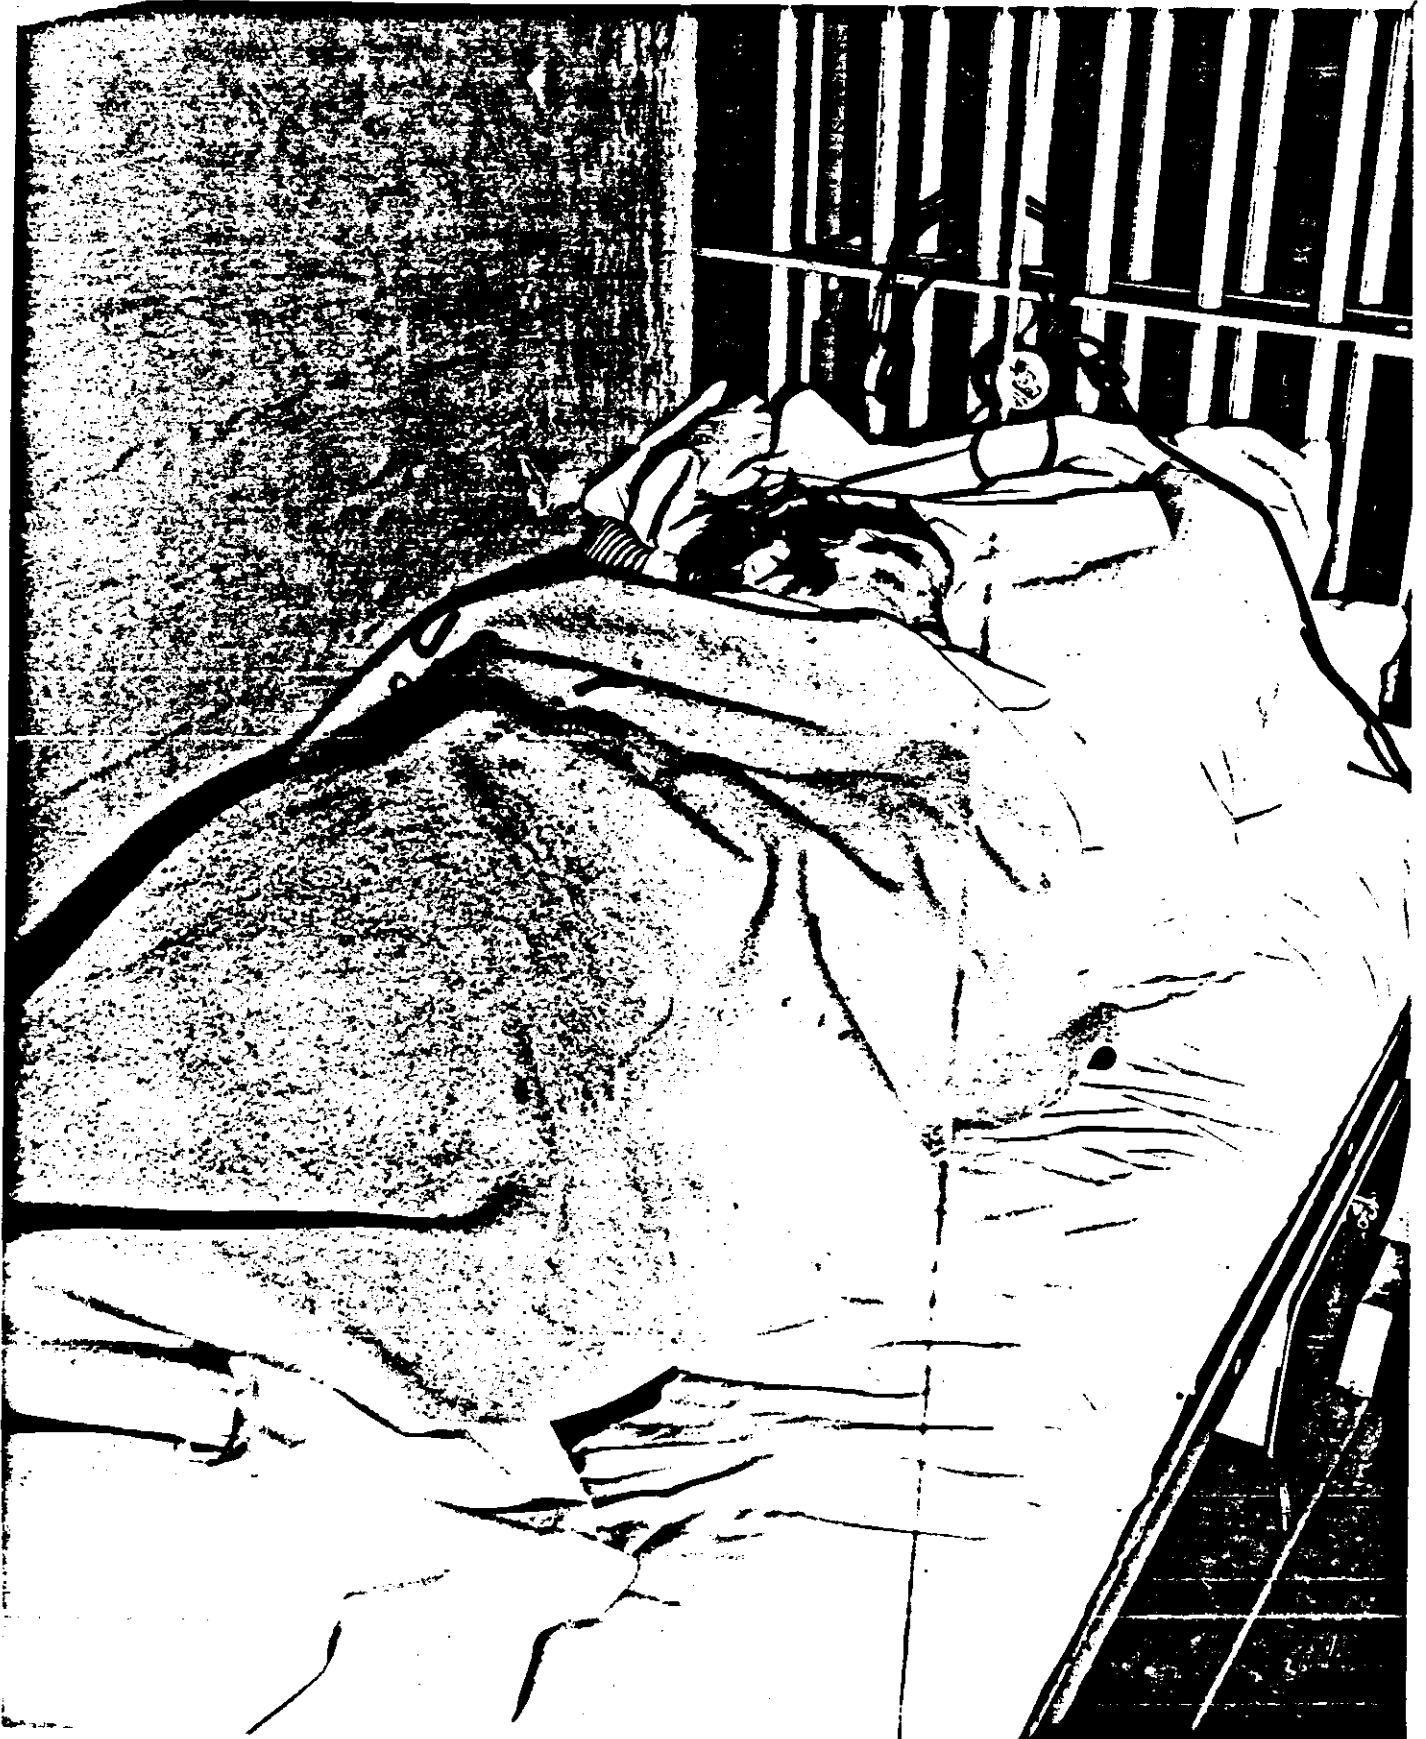
3-3 Photograph taken in Cell 152 B from foot of bed looking toward head of bed.
